Mountain Home Air Force Base
Photographs
November 15, 2007

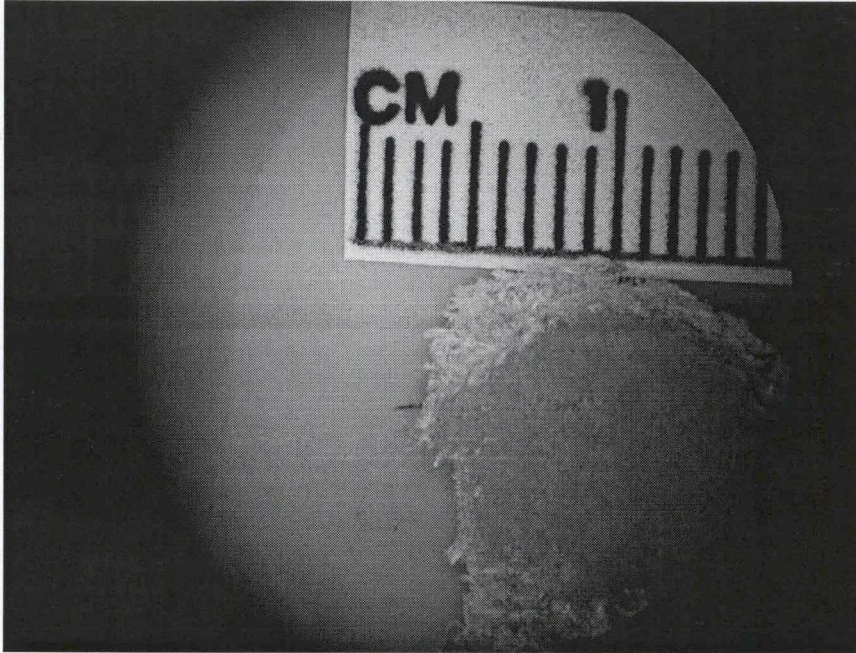
Figure 1 – White chrysotile and blue crocidolite fiber bundles protruding from the broken edge of cement asbestos pipe fragment, sample number 07464300, collected at the Phase 6 construction site at Mountain Home AFB. The image was acquired with the aid of a Wild M5 stereomicroscope at 6x magnification.

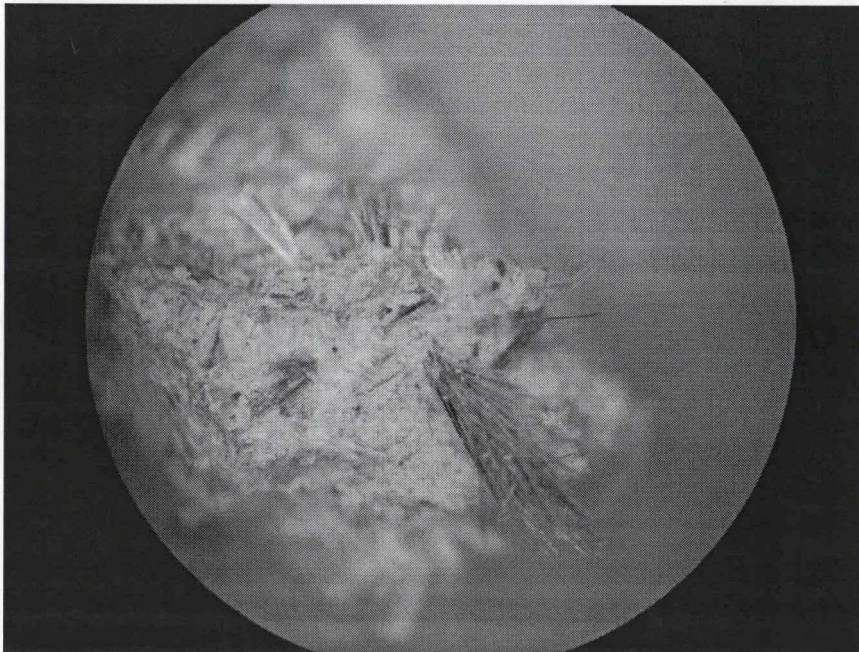
Figure 2 – White chrysotile and blue crocidolite fiber bundles protruding from the broken edge of cement asbestos pipe fragment, sample number 07464310, collected at the Verlinde Hill Debris Field at Mountain Home AFB. The image was acquired with the aid of a Wild M5 stereomicroscope at 25x magnification.

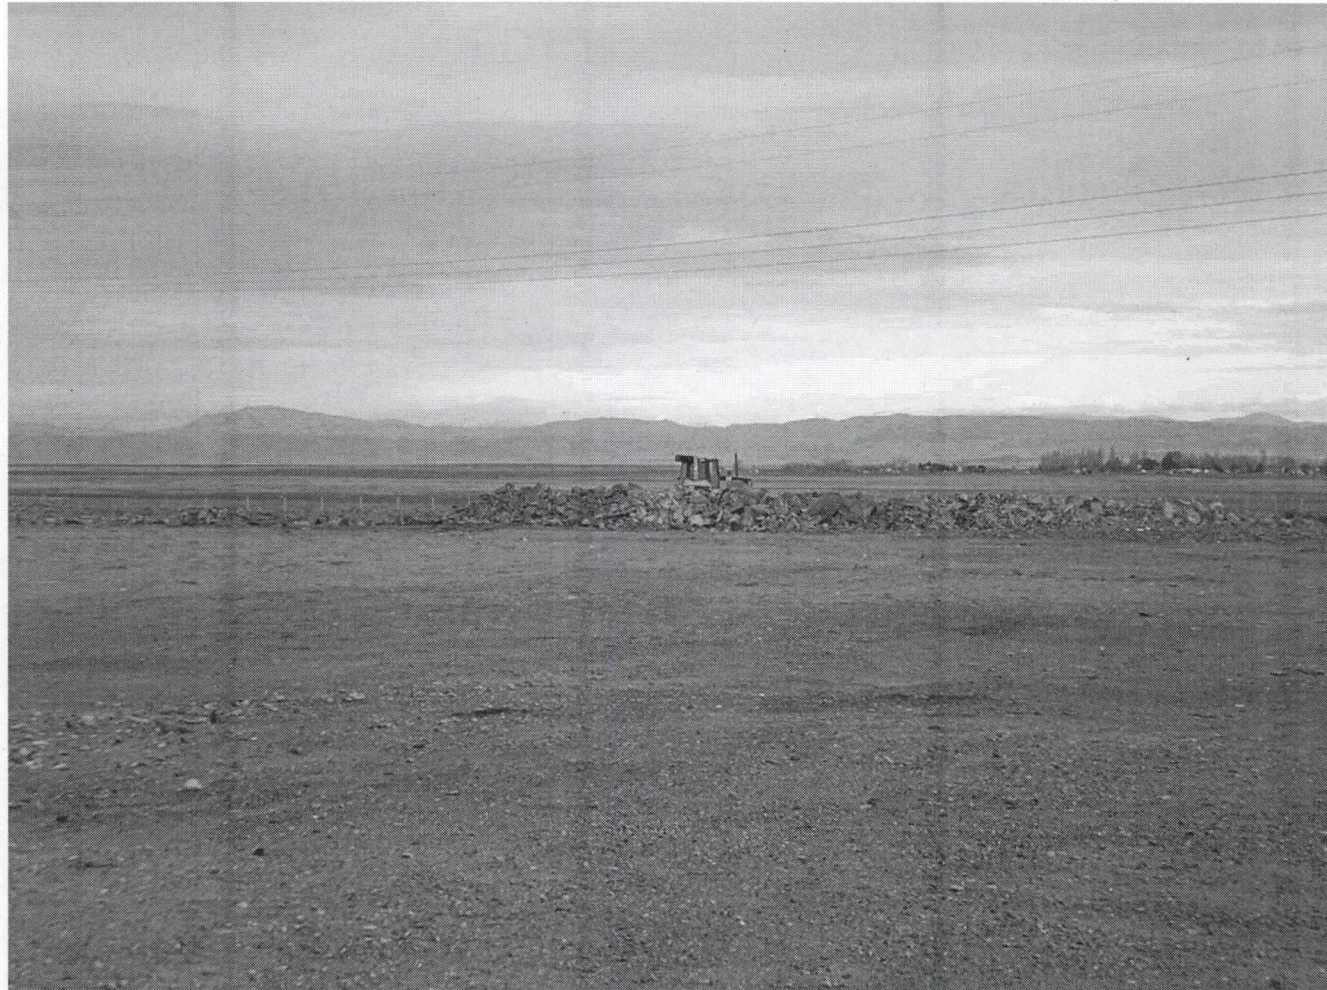
Photo 29: Verlinde Hills rubble pile – looking east – note large area of rubble which appeared to have been recently placed

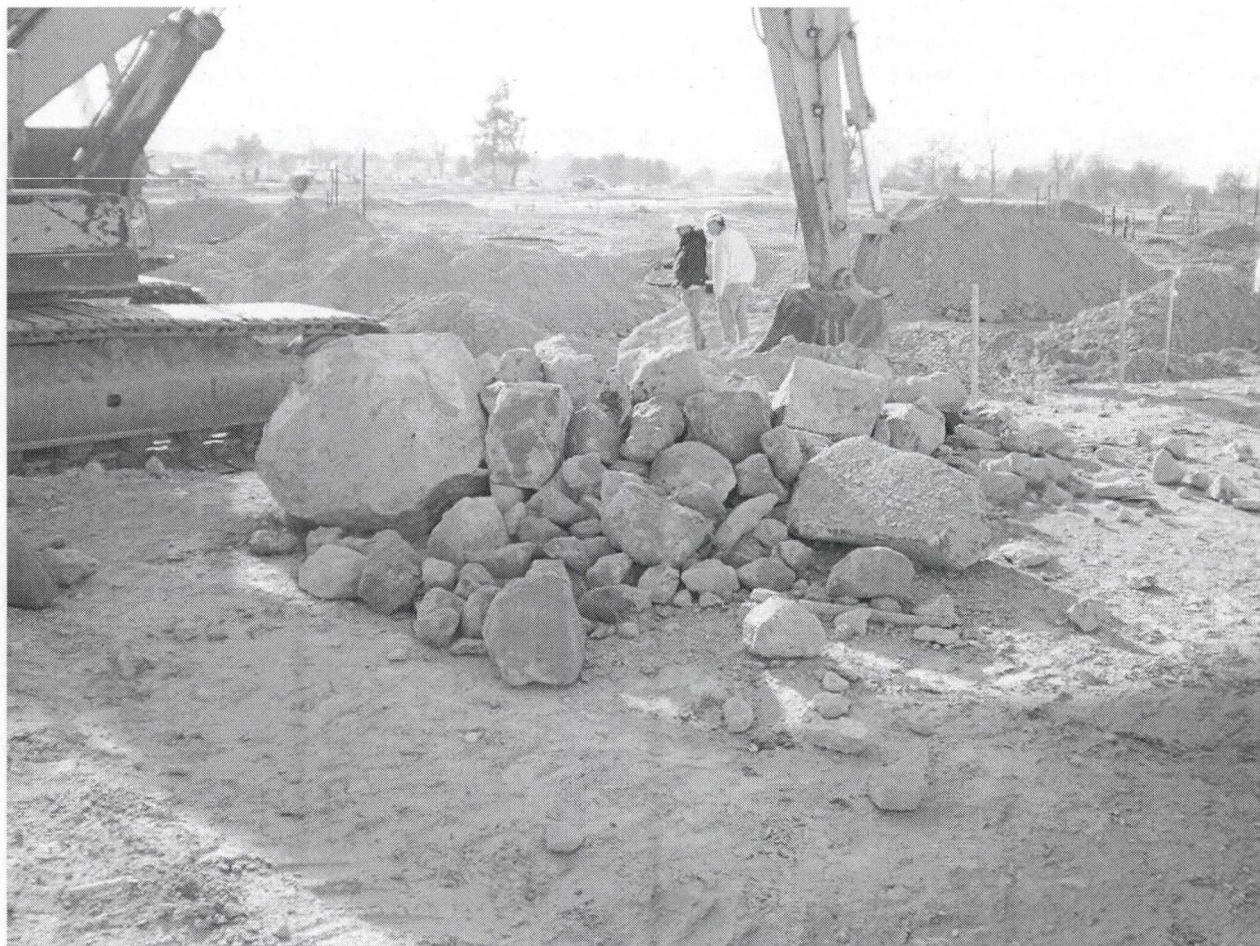
Photo 25: Rubble pile near south end of Phase 7 and north end of Phase 6- rubble had been processed through shaker bucket – transite pipe fragments observed in pile

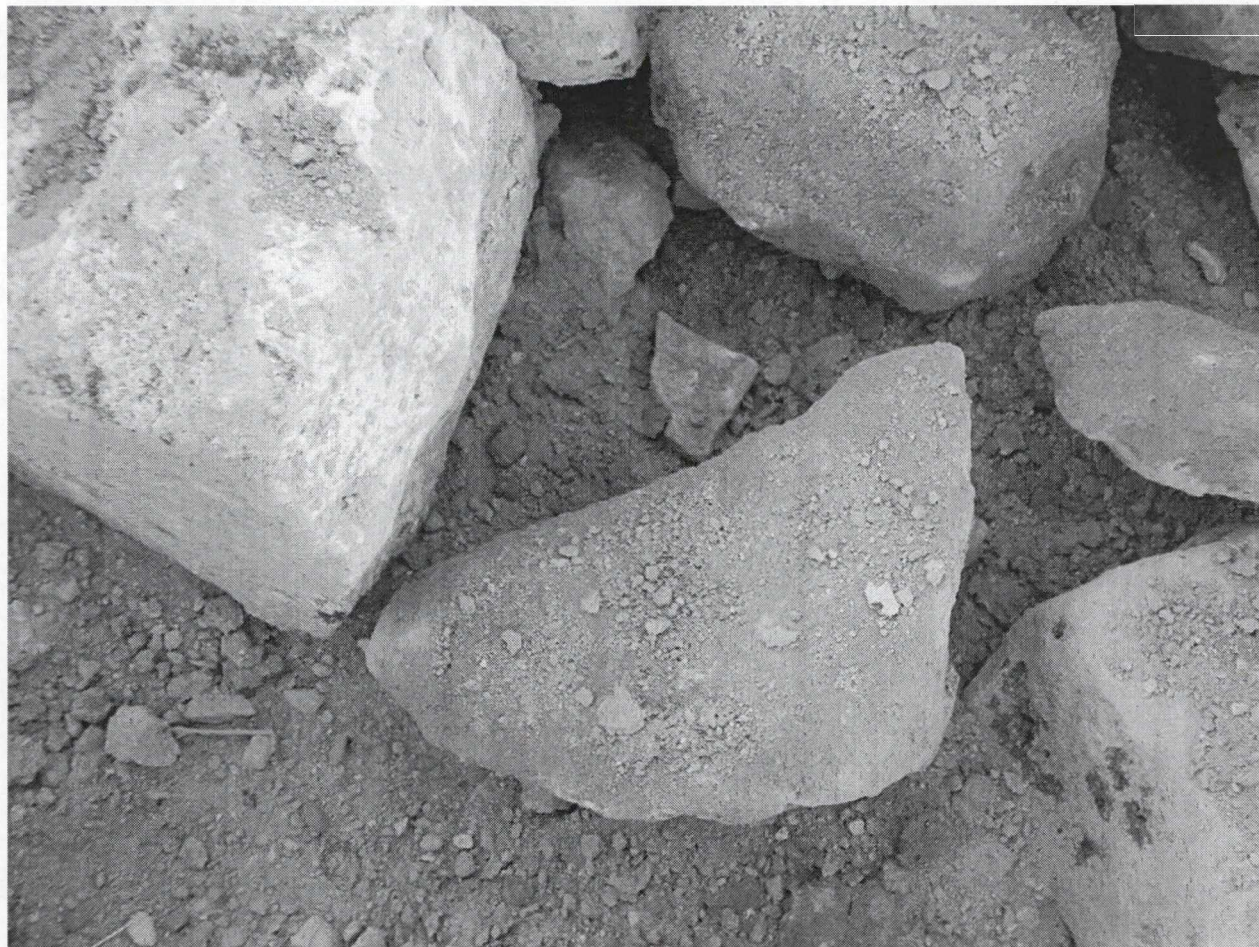
Photo 24: Probable transite pipe in rubble pile near south end of Phase 7 and north end of Phase 6- rubble had been processed through shaker bucket – transite was not marked for removal

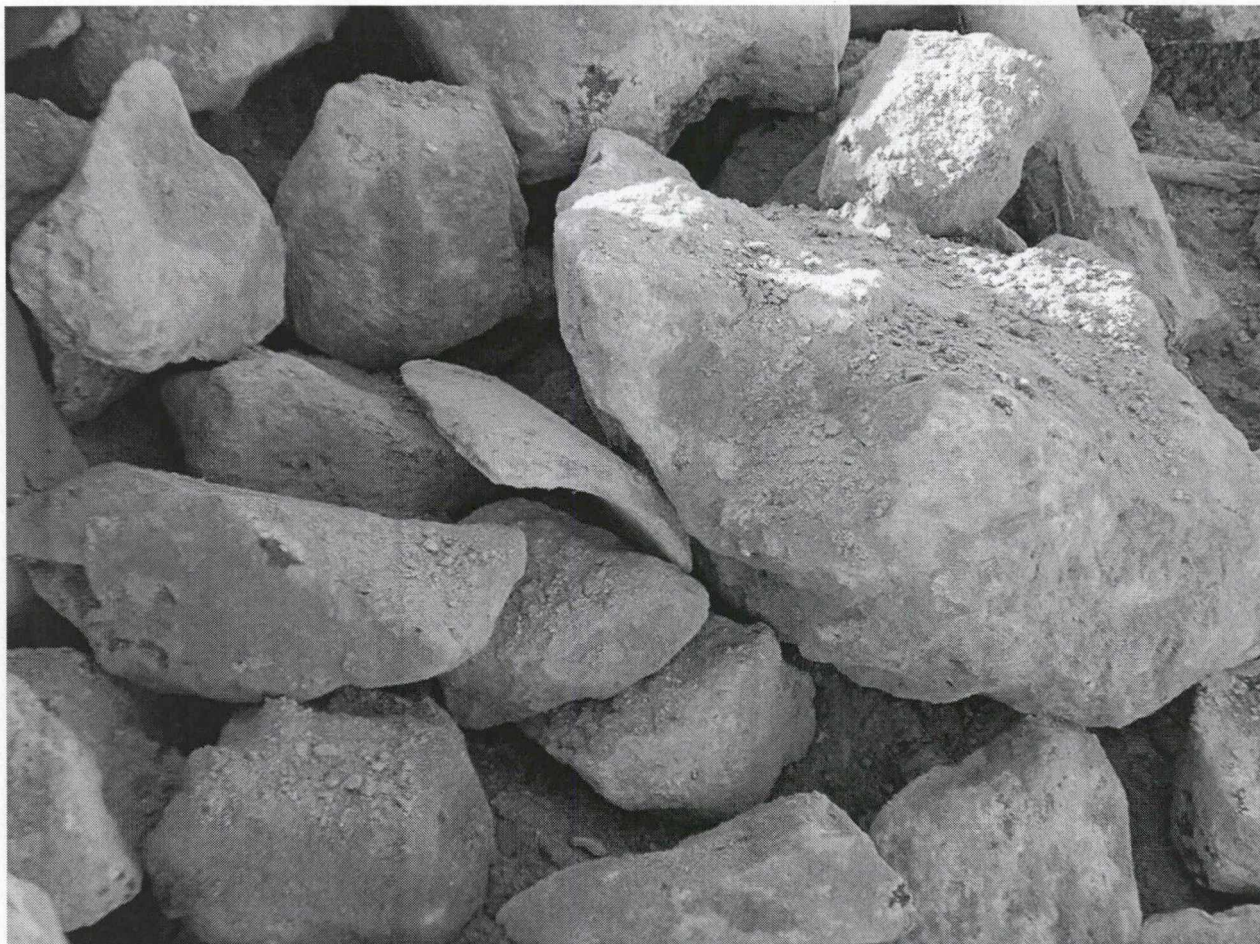
Photo 23: Probable transite pipe in rubble pile near south end of Phase 7 and north end of Phase 6- rubble had been processed through shaker bucket – transite was not marked for removal

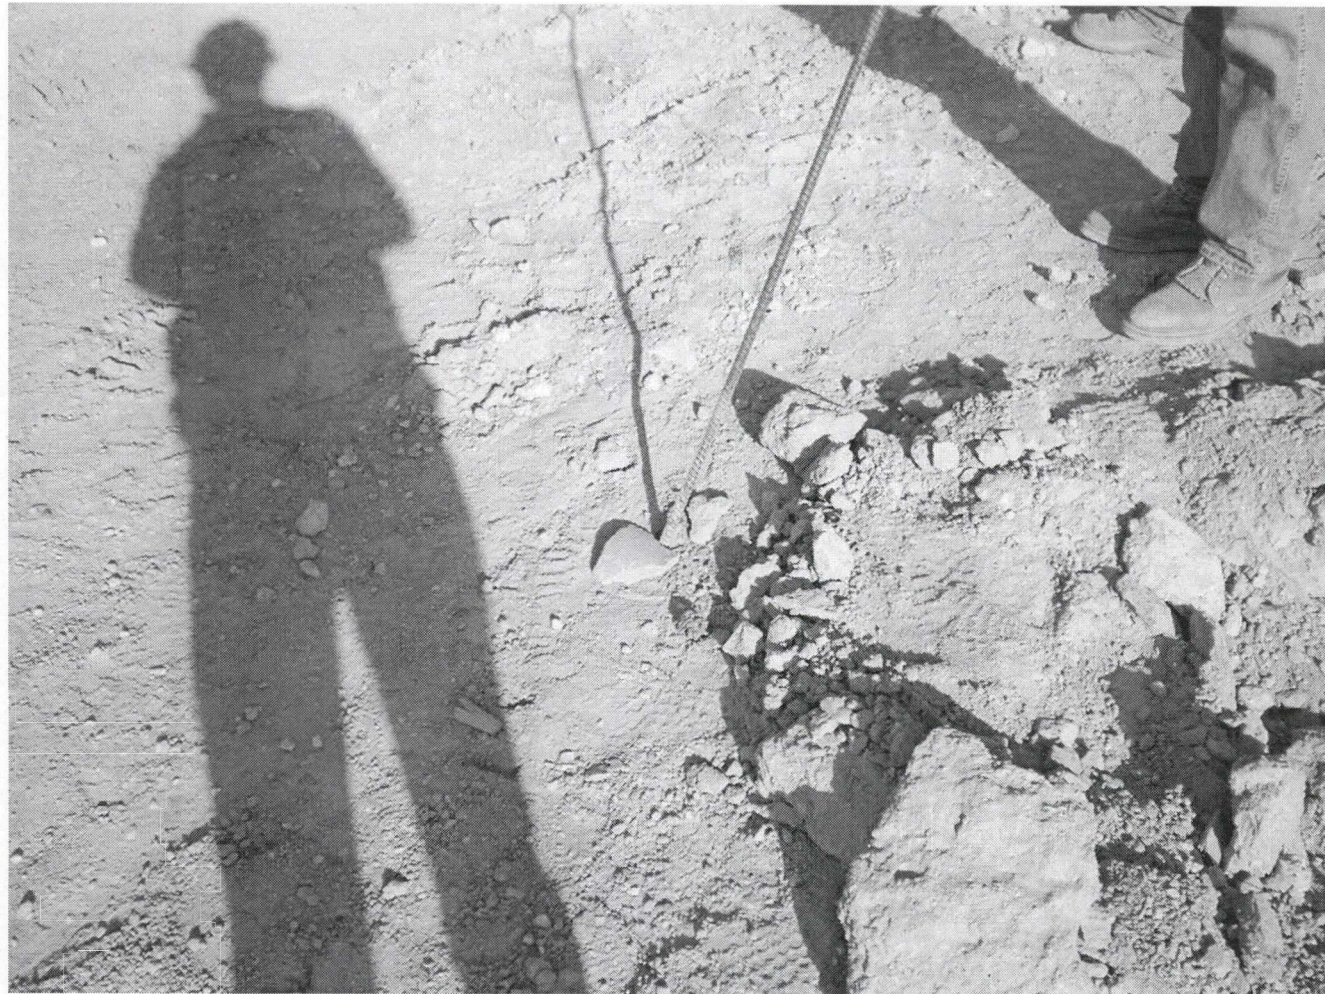
Photo 21: Probable transite pipe fragment – unmarked – adjacent to trench in Phase 7

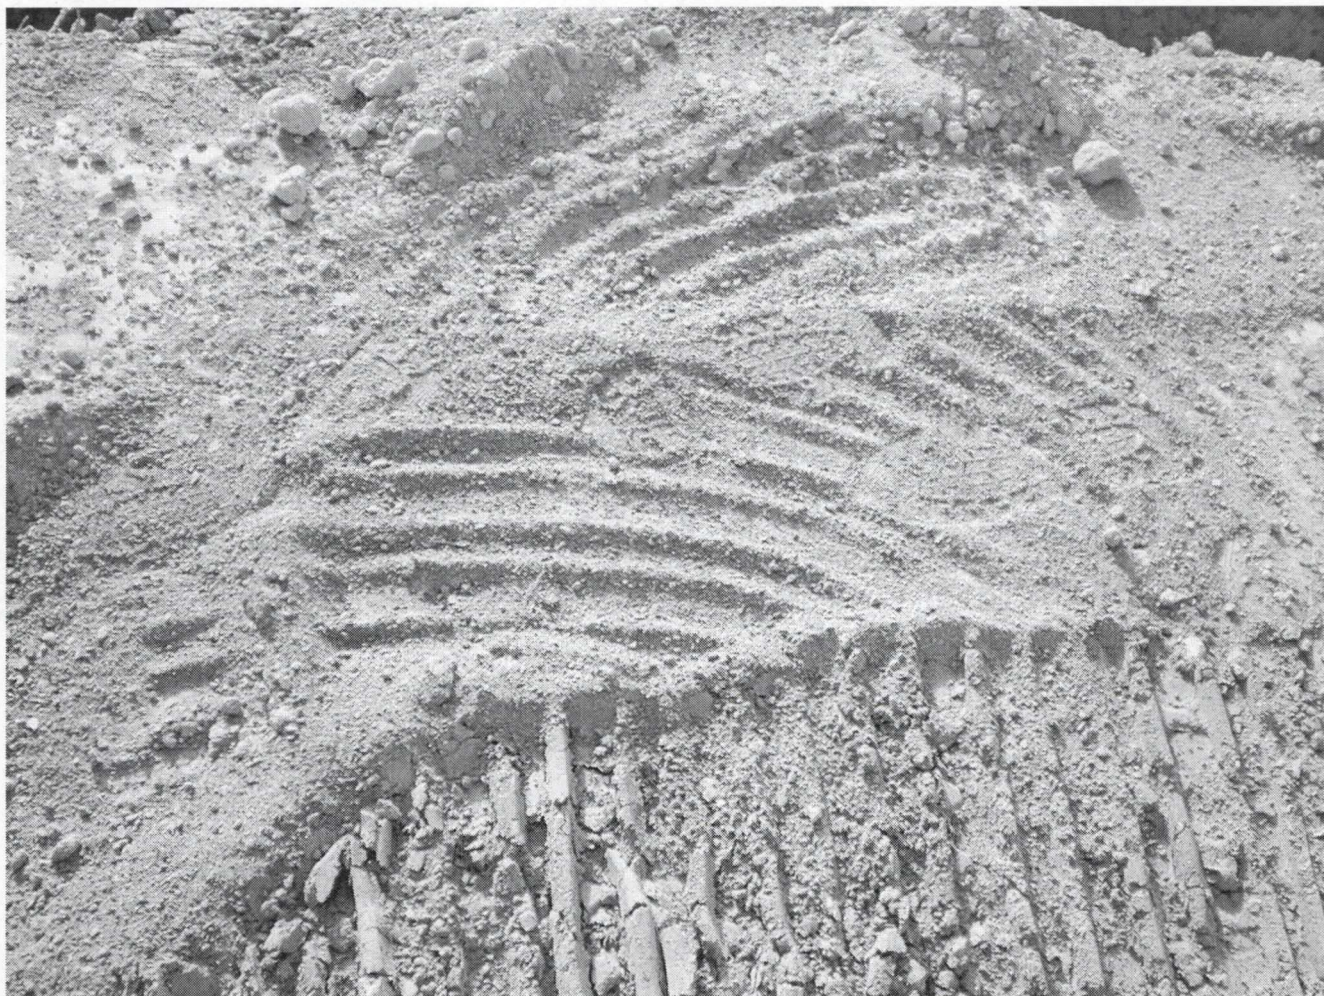
Photo 20: Probable transite pipe fragments – unmarked – in Phase 7 under excavator tracks

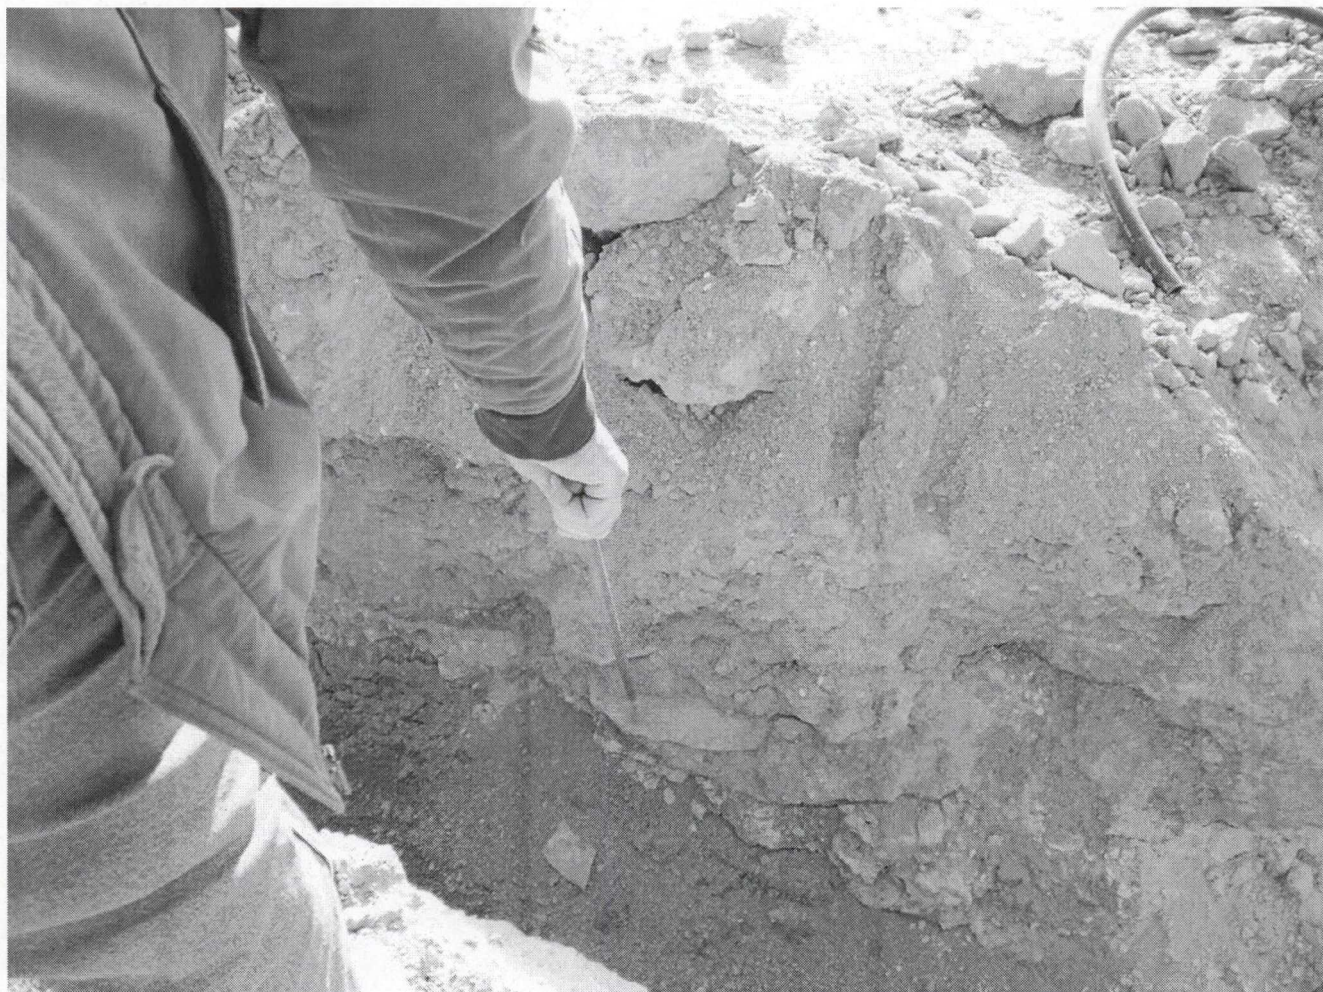
Photo 19: Probable transite pipe that had been broken and that extended parallel to trench in Phase 7

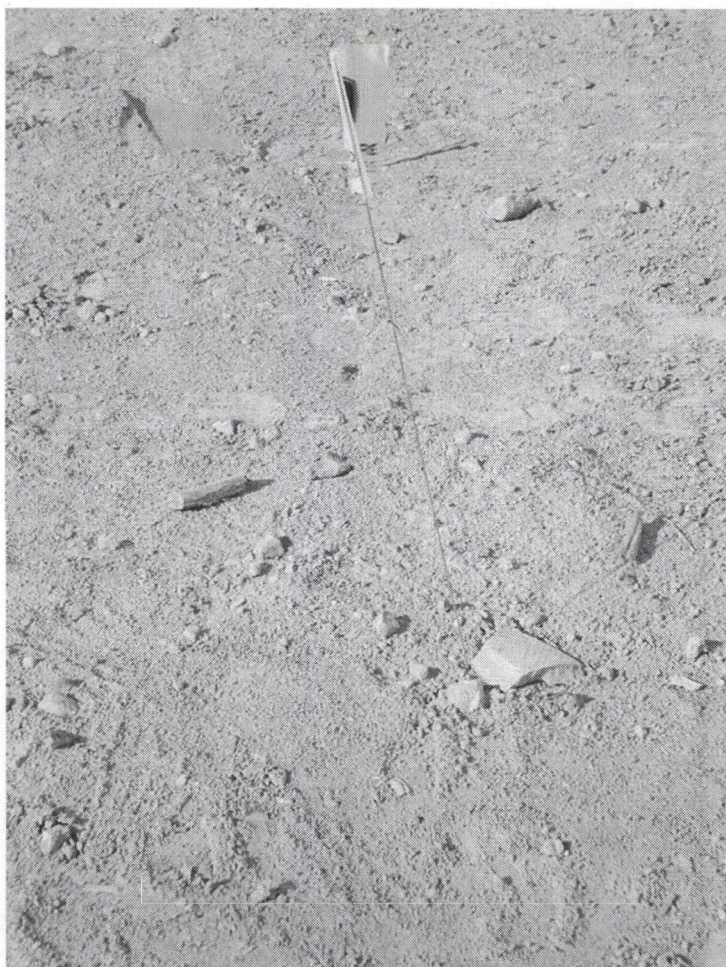
Photo 15: Example of probable transite pipe marked with flag – was under construction worker's truck – contractor moved truck

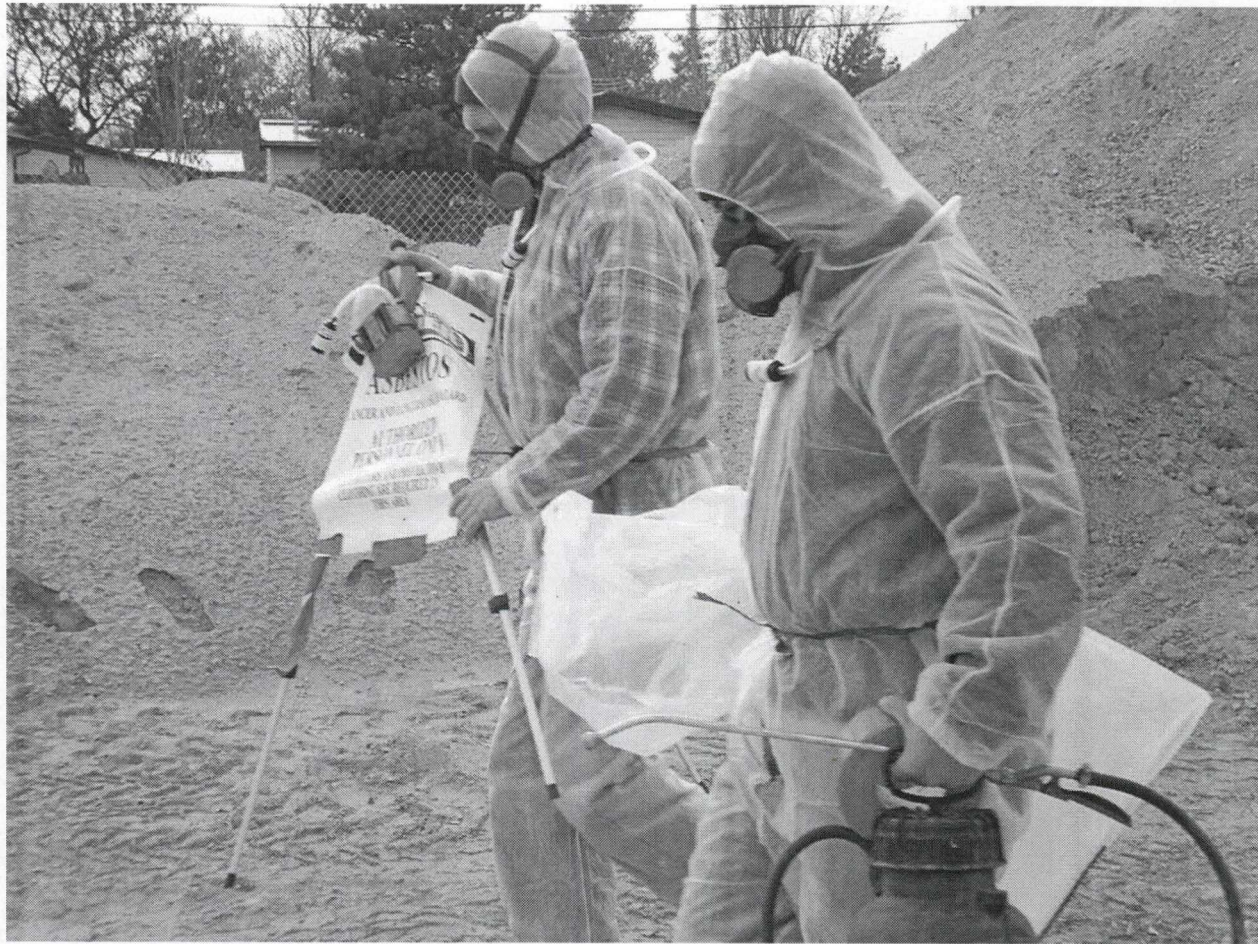
Photo 13: AAI employees picking up probable transite pipe – note warning sign and lack of gloves

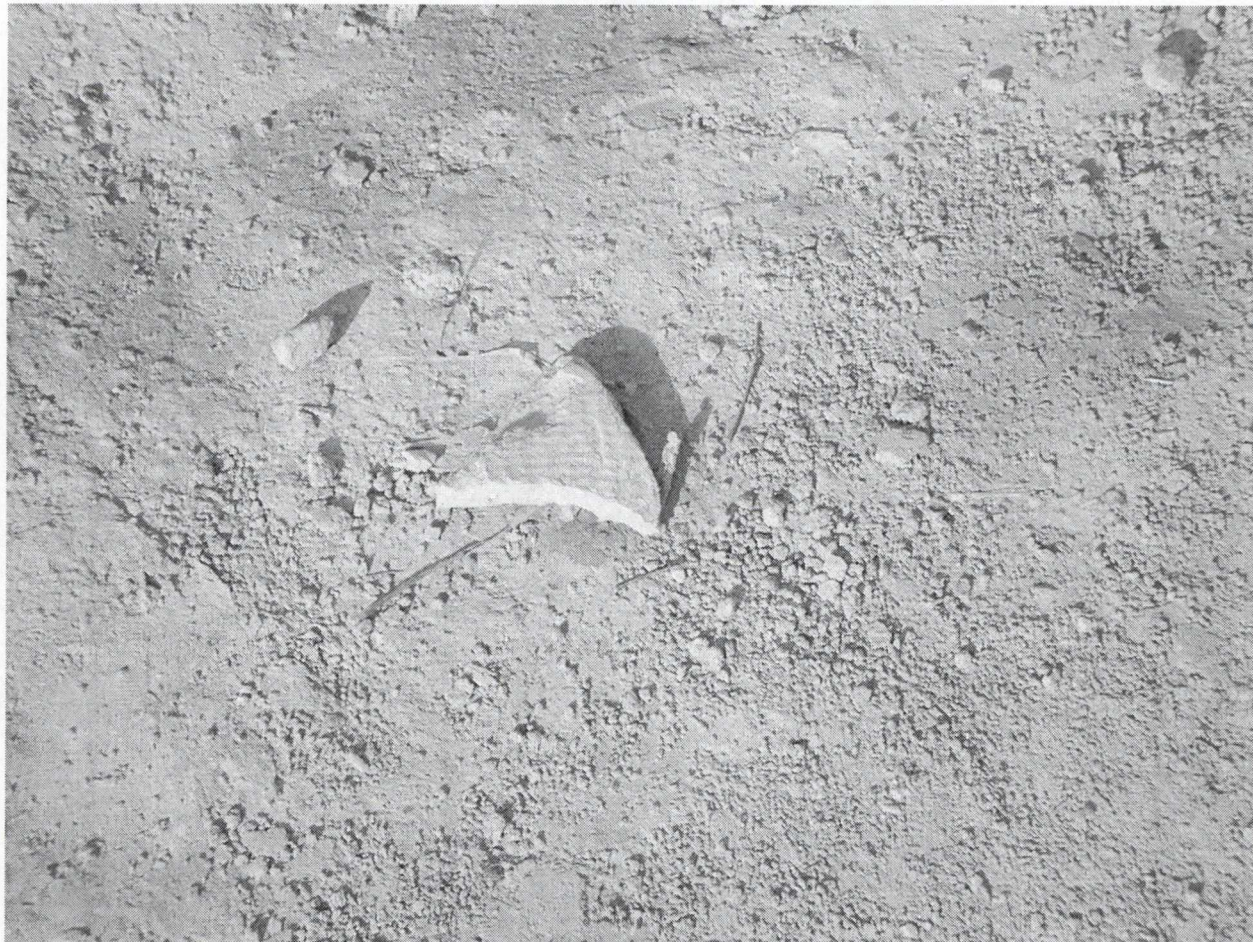
Photo 12: Fragment of probable transite pipe – had not been identified or located by MHAFB, USCOE, Parsons Evergreene, IHR or AAI employees

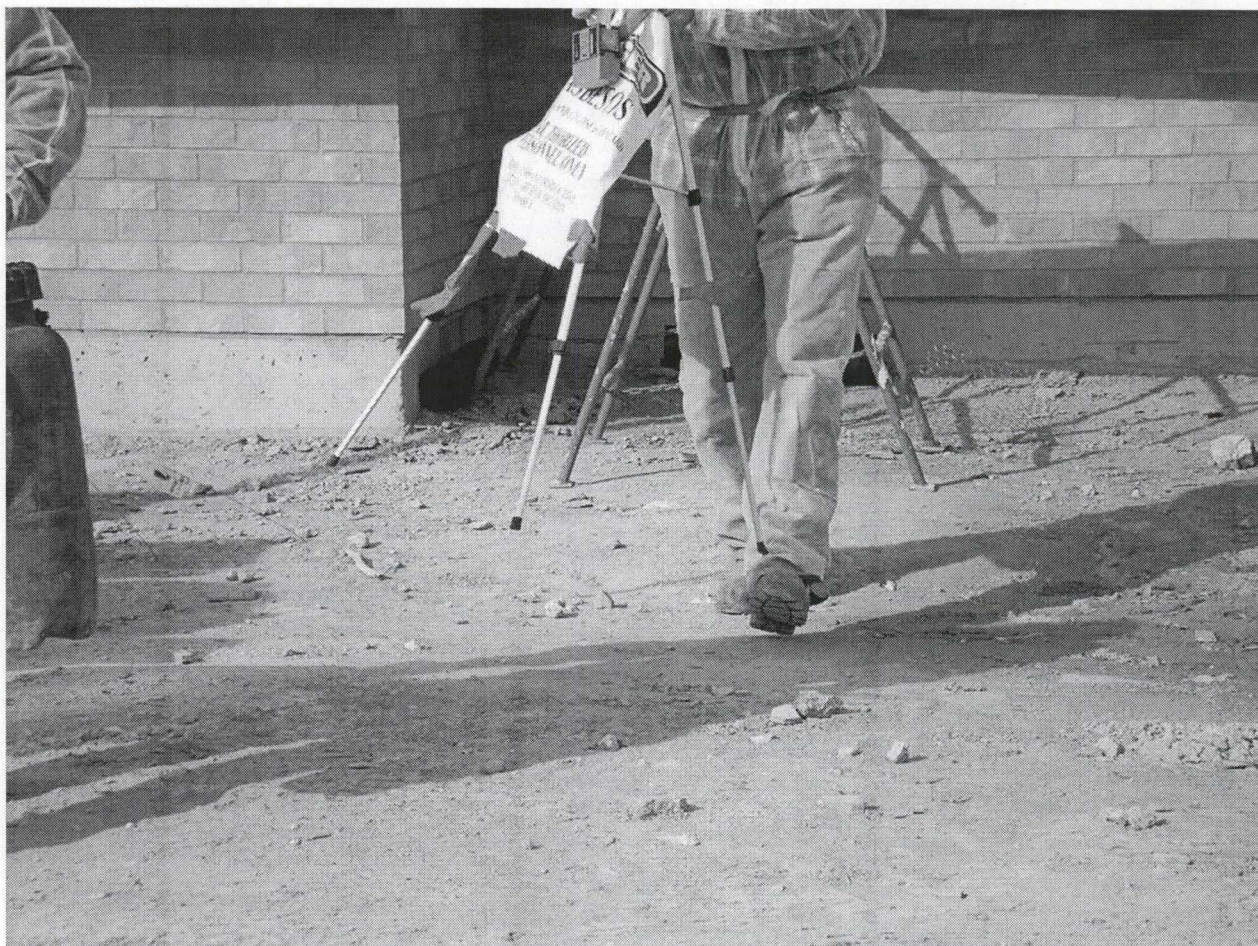
Photo 11: Note tripod warning of asbestos in the area and "authorized personnel only – fragment of probable transite pipe in the foreground – note lack of booties

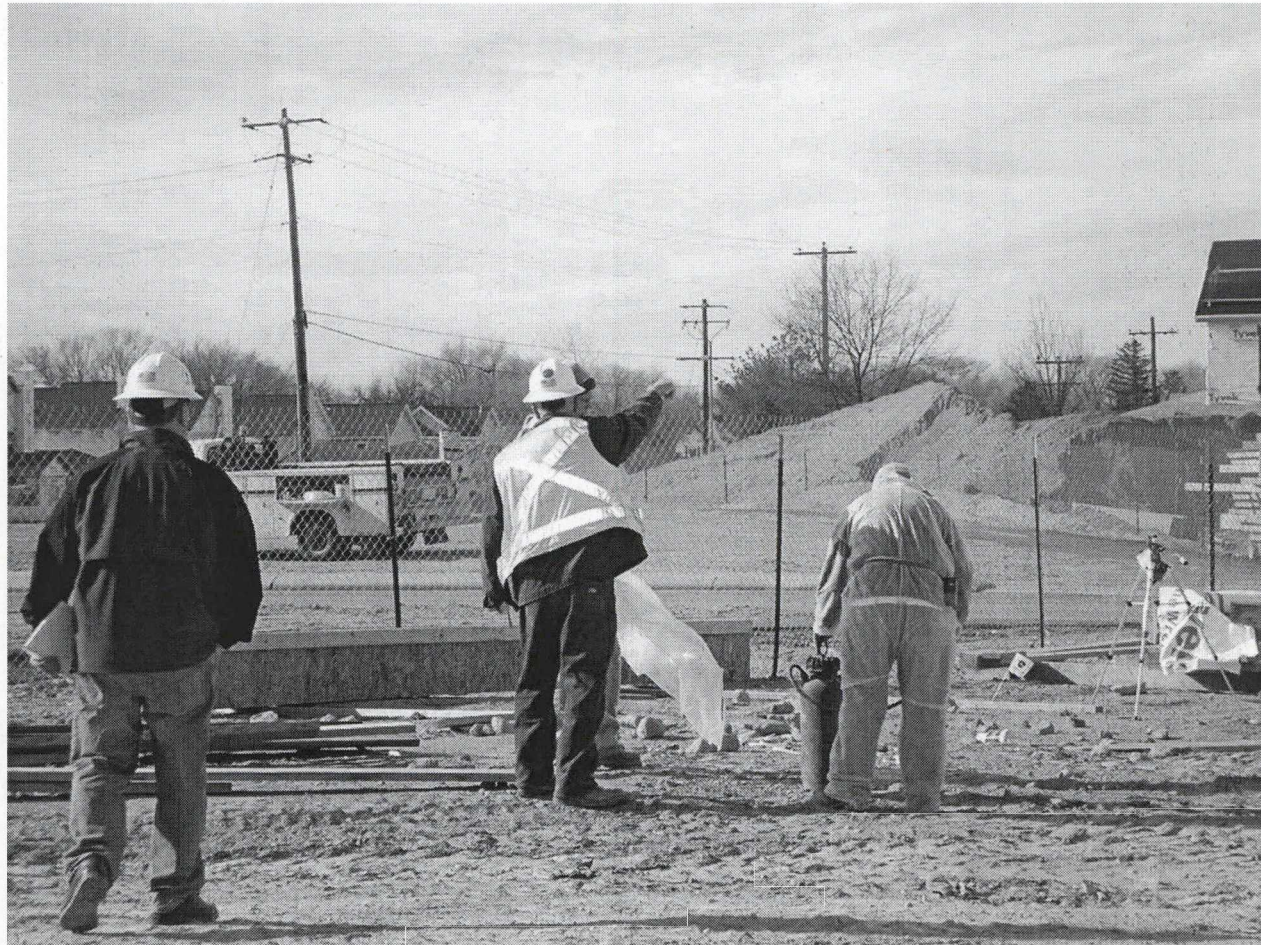
Photo 10: AAI employee wetting probable transite pipe – note flag marking pipe, tripod with sign warning asbestos is present in the area

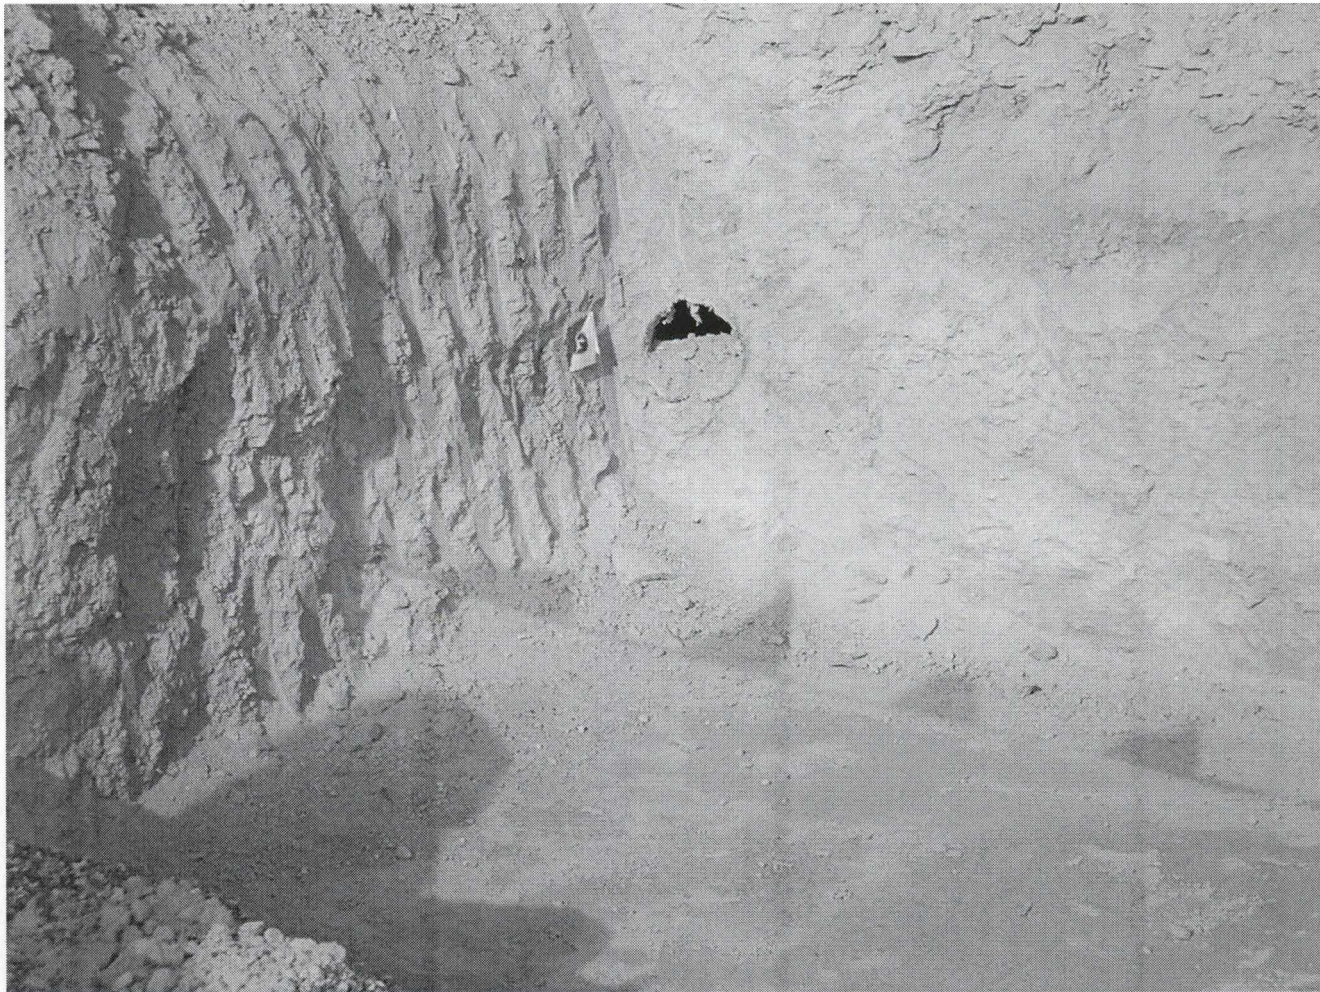
Photo 9: Probable transite pipe (see Photo 8) extending out of side wall of excavation – note pipe fragment below pipe

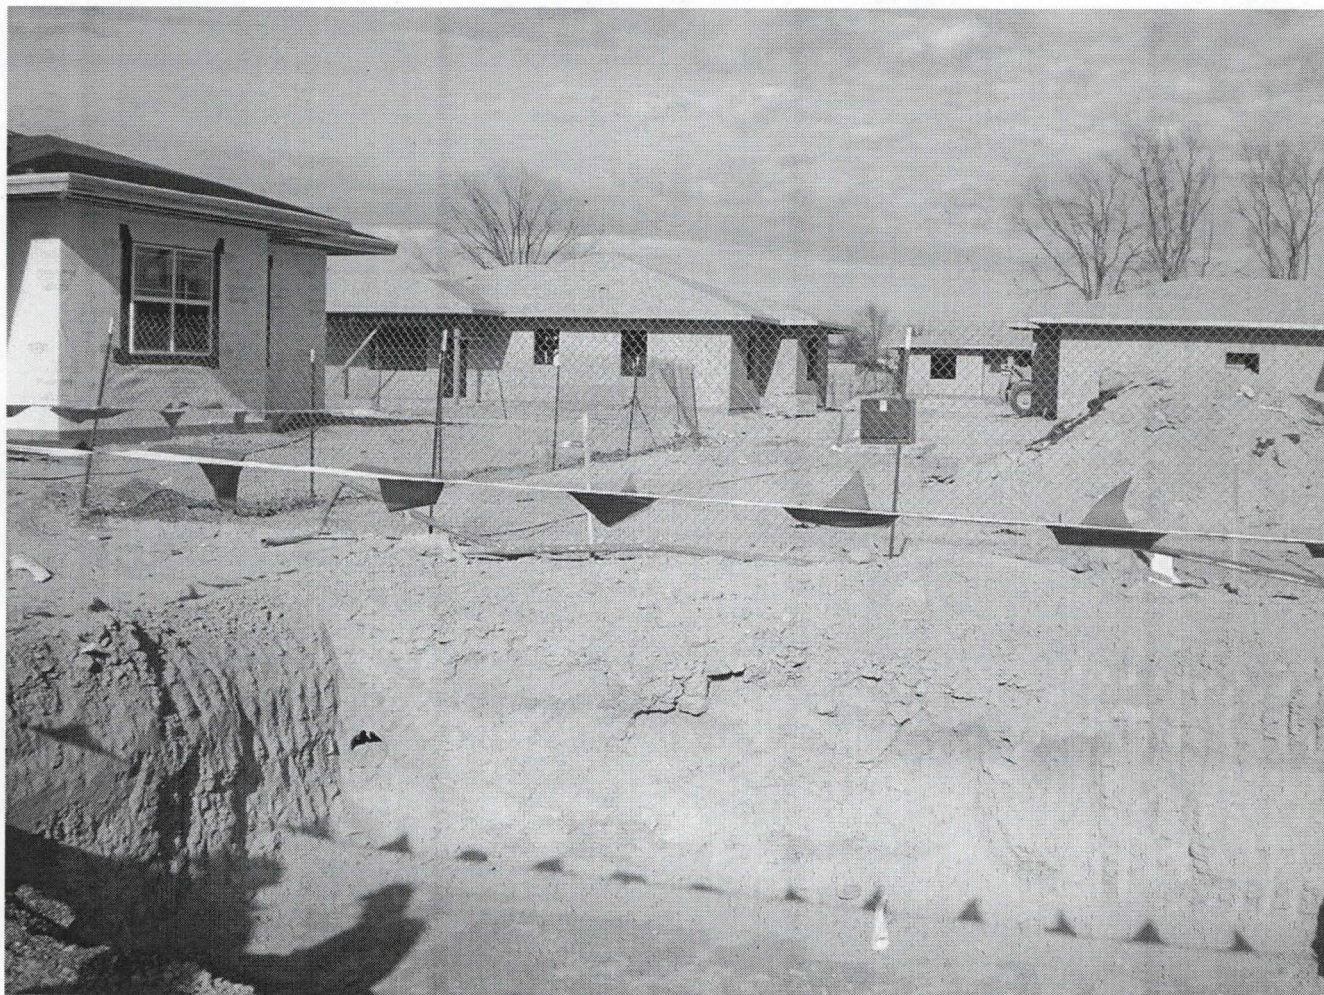
Photo 8: Excavation in Phase 6 – note probable transite pipe extending out of back wall of excavation, near left side of photo

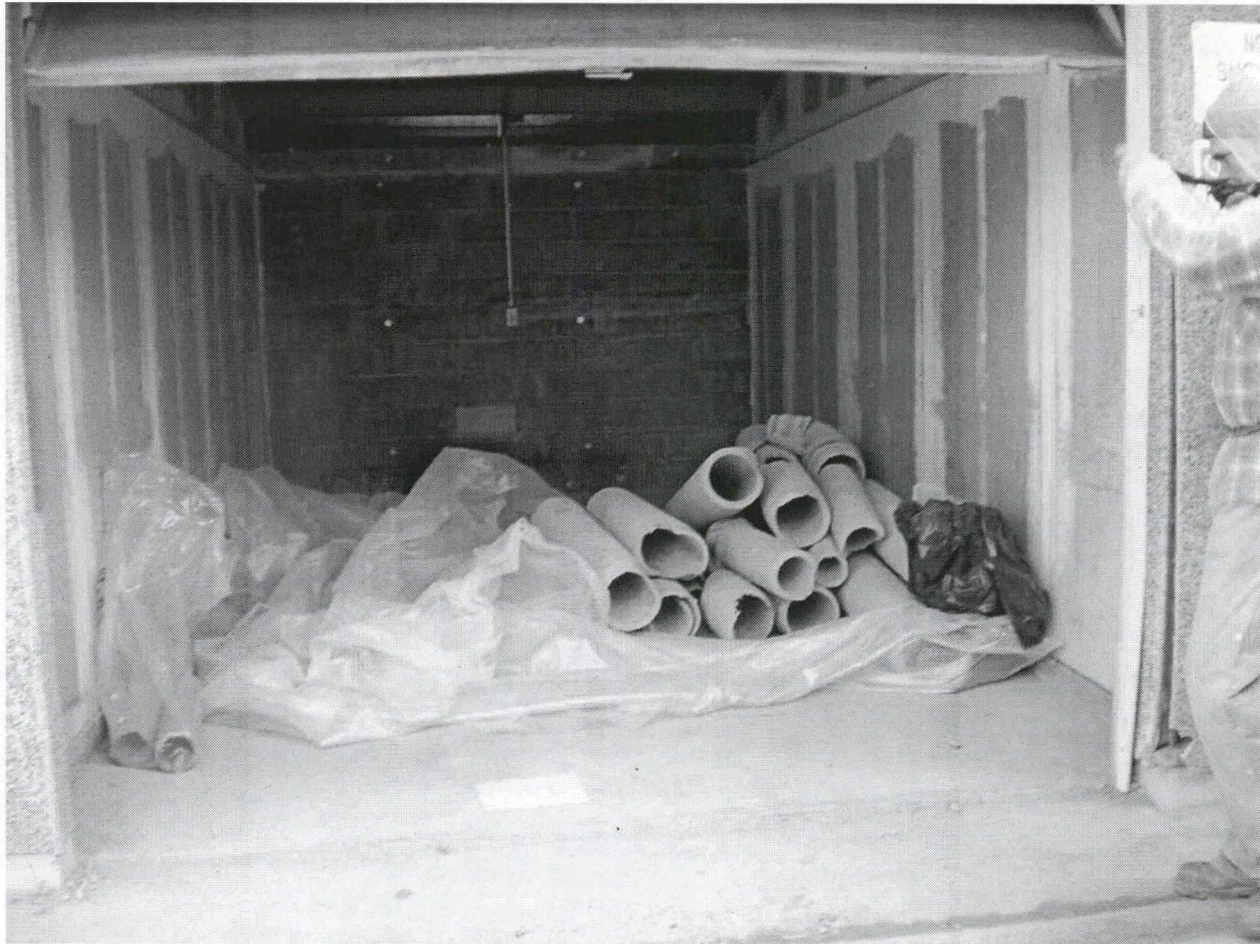
Photo 7: Broken probable transite pipe on plastic, but uncovered, inside "Unit D" – pipe was not covered when unit was opened – note worker from AAI putting on respirator

The inspection team observed one of the two satellite locations where asbestos pipe was being stored for disposal. This was located in a storage unit (D) on the Phase VI site near the portable trailers used for Parsons Construction offices. It was noted that the front surface of the door was placarded with an 8½ x 11 inch asbestos warning sign. The inspection team requested that the workers open the door and allow them to observe the material stored in the room. Inside storage unit D, the inspection team observed a stack of dry cement asbestos pipe sections laying on a plastic tarp on the surface of the floor. The workers quickly put their respirators on, entered the storage unit, and pulled the plastic tarp over the top of the sections of pipe. A short time after the workers came out of the storage unit they entered the Parsons Construction offices. They did this while dressed in the same coveralls they wore inside the storage unit without performing decontamination.

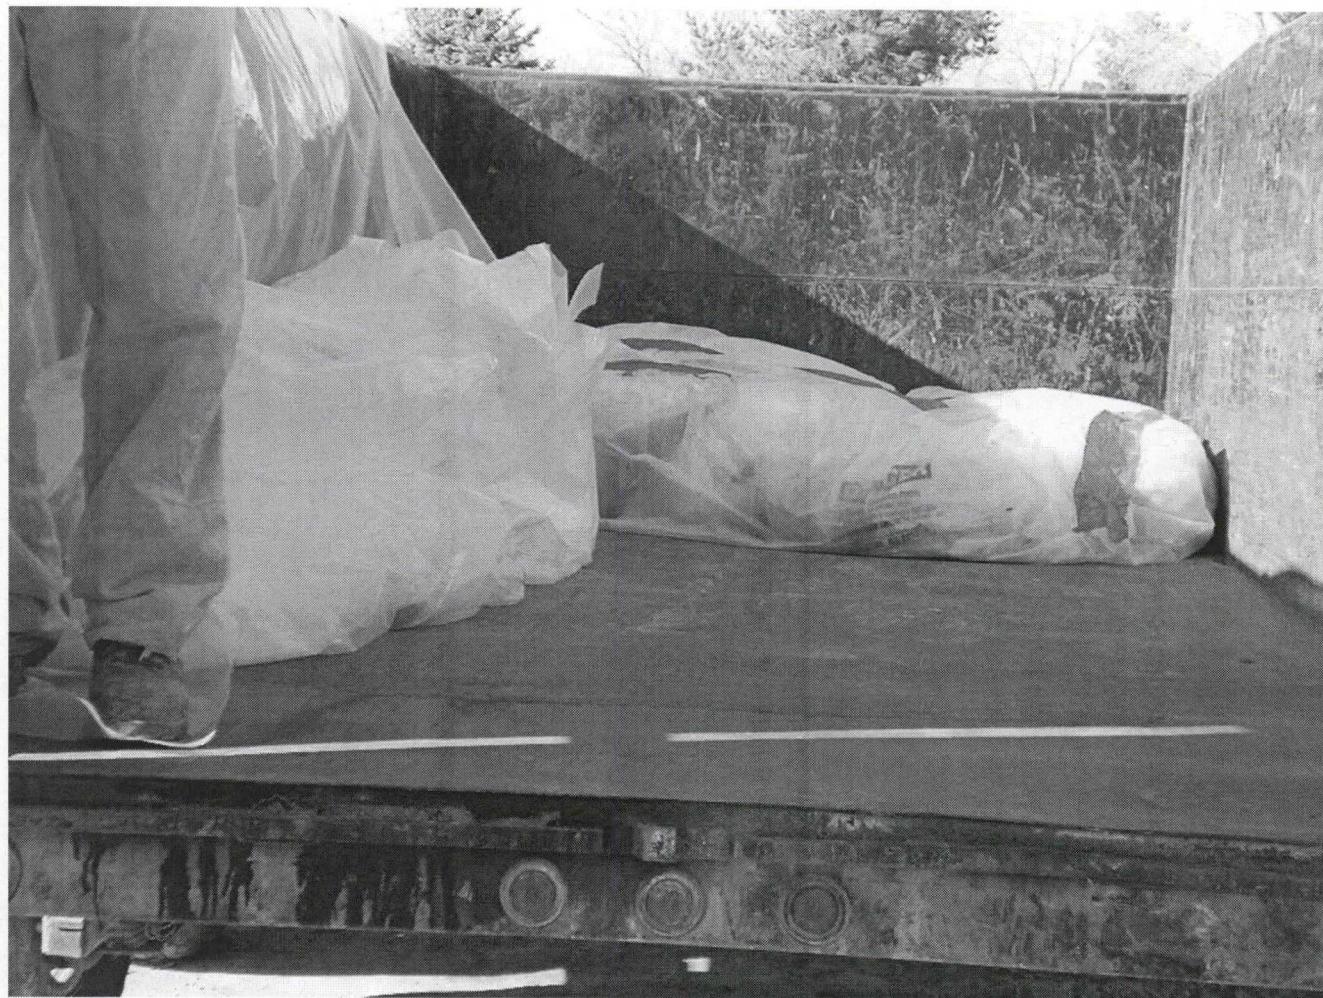
Photo 3: Plastic wrapped transite (asbestos containing) pipe in back of truck near Hunt office in Phase 7

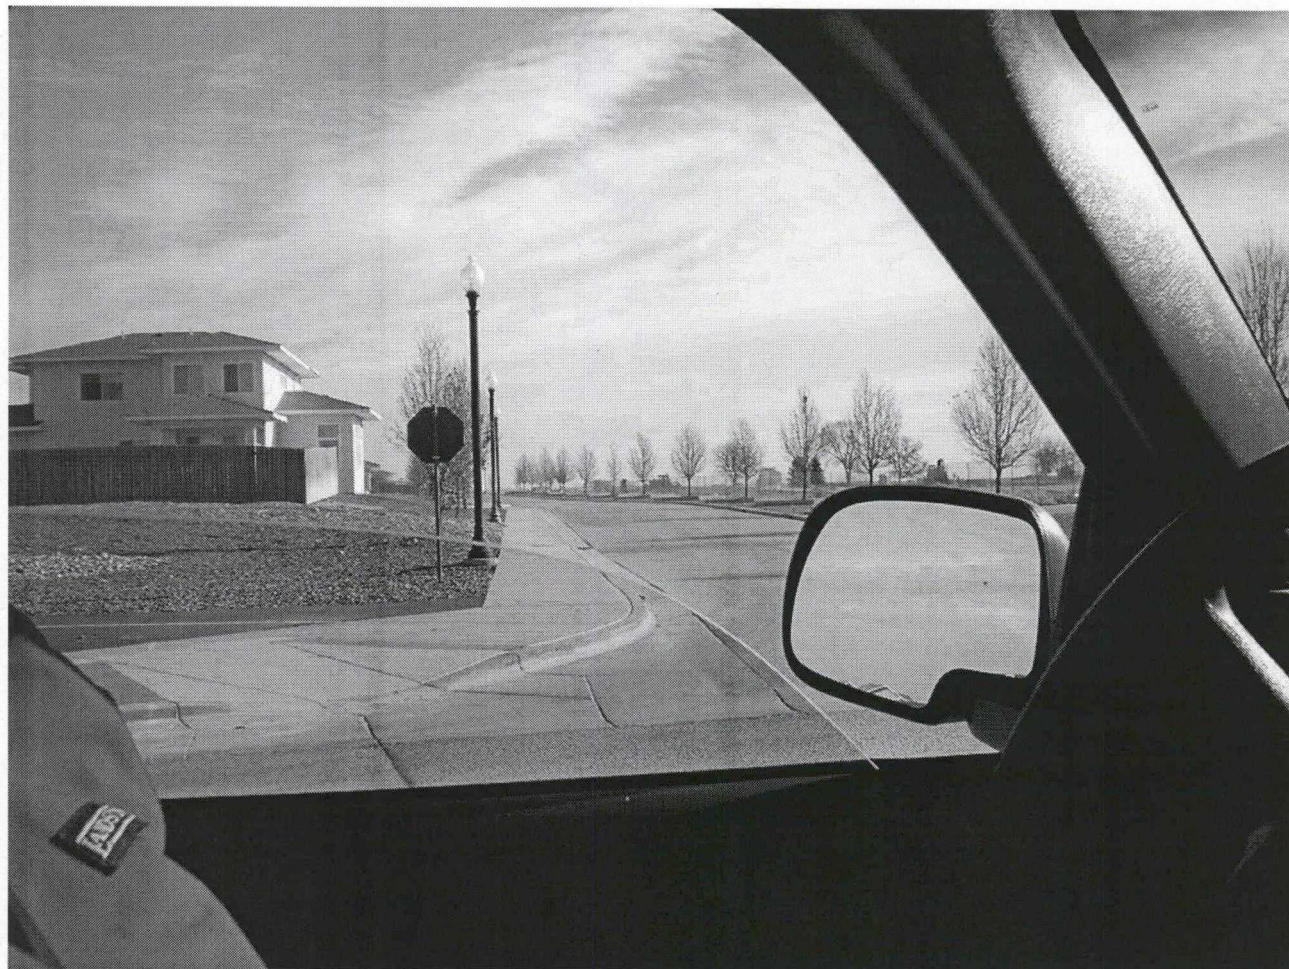
Photo 1: North boundary of Phase 7 – Fugitive dust was leaving boundary of construction area and drifting into housing area
